EFFECTS OF ENVIRONMENT ON CREEP BEHAVIOR OF NEXTEL

720/ALUMINA-MULLITE CERAMIC COMPOSITE AT 1200°C

THESIS

AFIT/GAE/ENY/08-M11

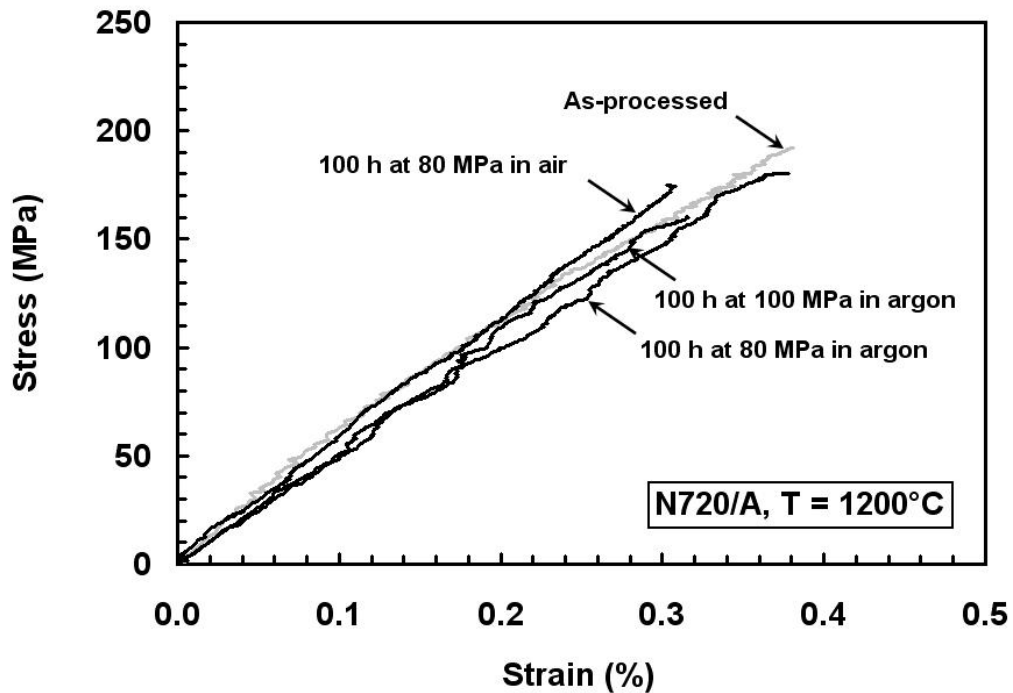
Figure 31. Effect of prior creep at 1200°C in air and in argon on tensile stress-strain behavior of N720/A composite. Data from references [13, 23, 24, 15].

The N720/A material subjected to 100 h of prior creep at 80 MPa in air retained over 90% of its tensile strength. Loss in elastic modulus was limited to 14%. For the specimens subjected to prior creep in argon, tensile strength retention reached 83% while loss in elastic modulus was 20% [23]. After 100 h of prior creep in air at 73 MPa (equivalent to 80 MPa for $V_f = 0.44$), the tensile strength of the N720/AM composite is increased by 9% and the elastic modulus is reduced by 6%. Following prior creep at 91 MPa (equivalent to 100 MPa for $V_f = 0.44$), the strength of the N720/AM CMC is increased by 10% while the modulus is decreased 10%. Failure strain of the N720/AM composite was not significantly affected by prior creep.

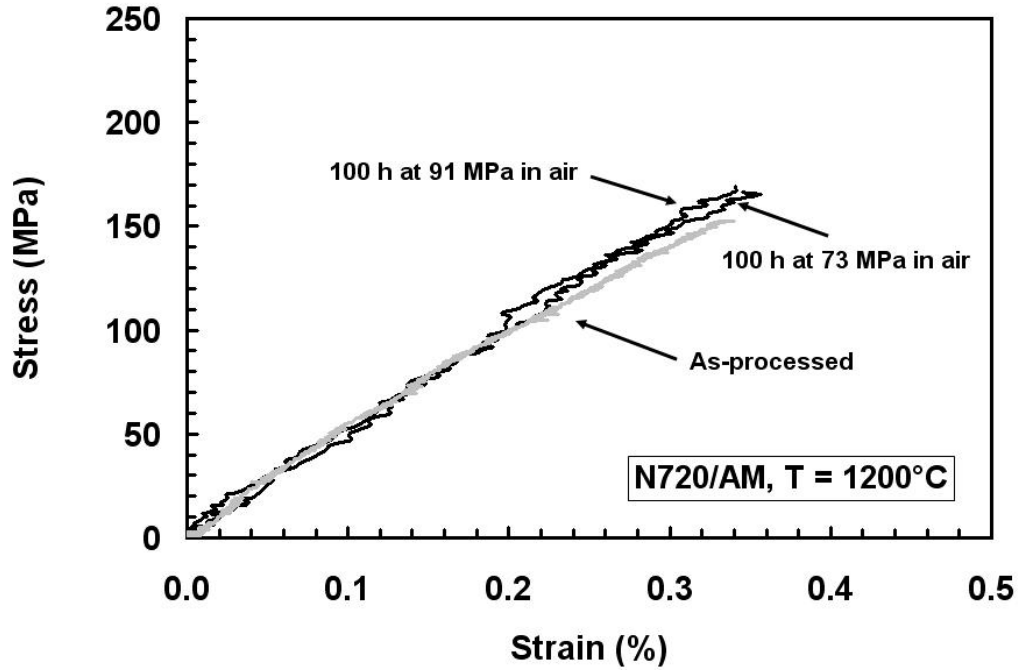
Figure 32. Effect of prior creep at 1200°C in air and in argon on tensile stress-strain behavior of N720/AM composite.

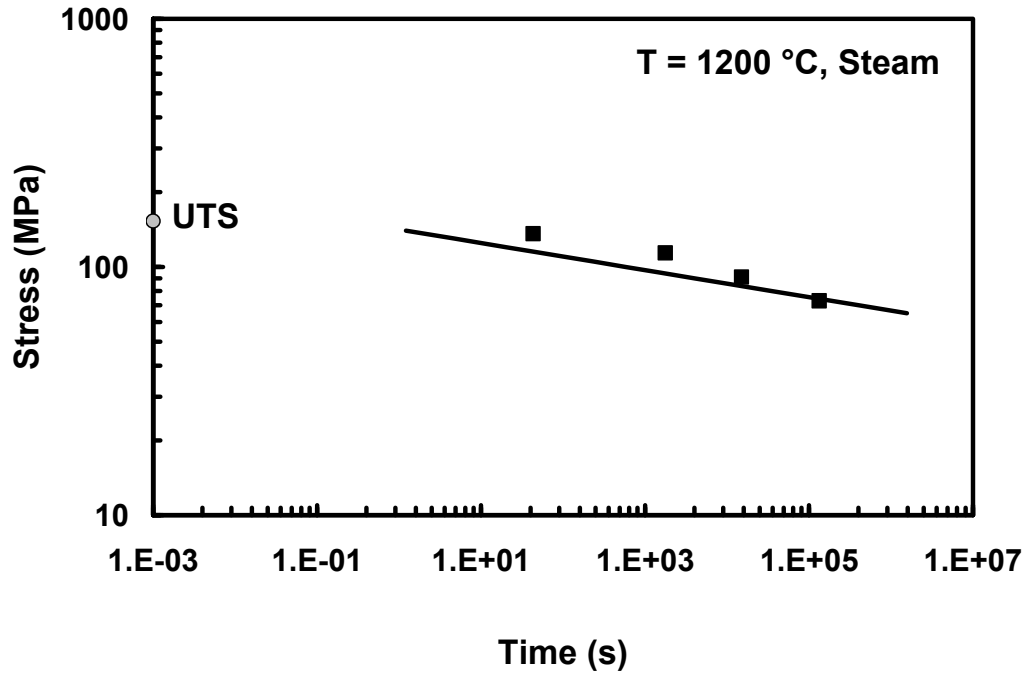
Figure 33. Creep stress vs. time to rupture for N720/AM ceramic composite at 1200°C in steam. The solid line represents prediction made based on Eq. (9) from the results of constant stress-rate tests.

where t_f and σ are time to failure and applied creep stress, respectively. The predicted creep lifetimes in steam are shown in Figure 33 as a solid line. A good agreement between the predictions and the experimental results indicates that in both tensile creep tests and in constant stress-rate tension tests at 1200 °C in steam, the slow crack growth is indeed the governing failure mechanism for N720/AM CMC. The dependence of tensile strength on loading rate together with the reasonable prediction of creep lifetimes from constant stress-rate test data suggest that delayed failure of the N720/A CMC at 1200 °C in steam is governed by the power-law type subcritical crack growth. These results point to stress-corrosion as the mechanism behind the degraded tensile creep performance in steam.

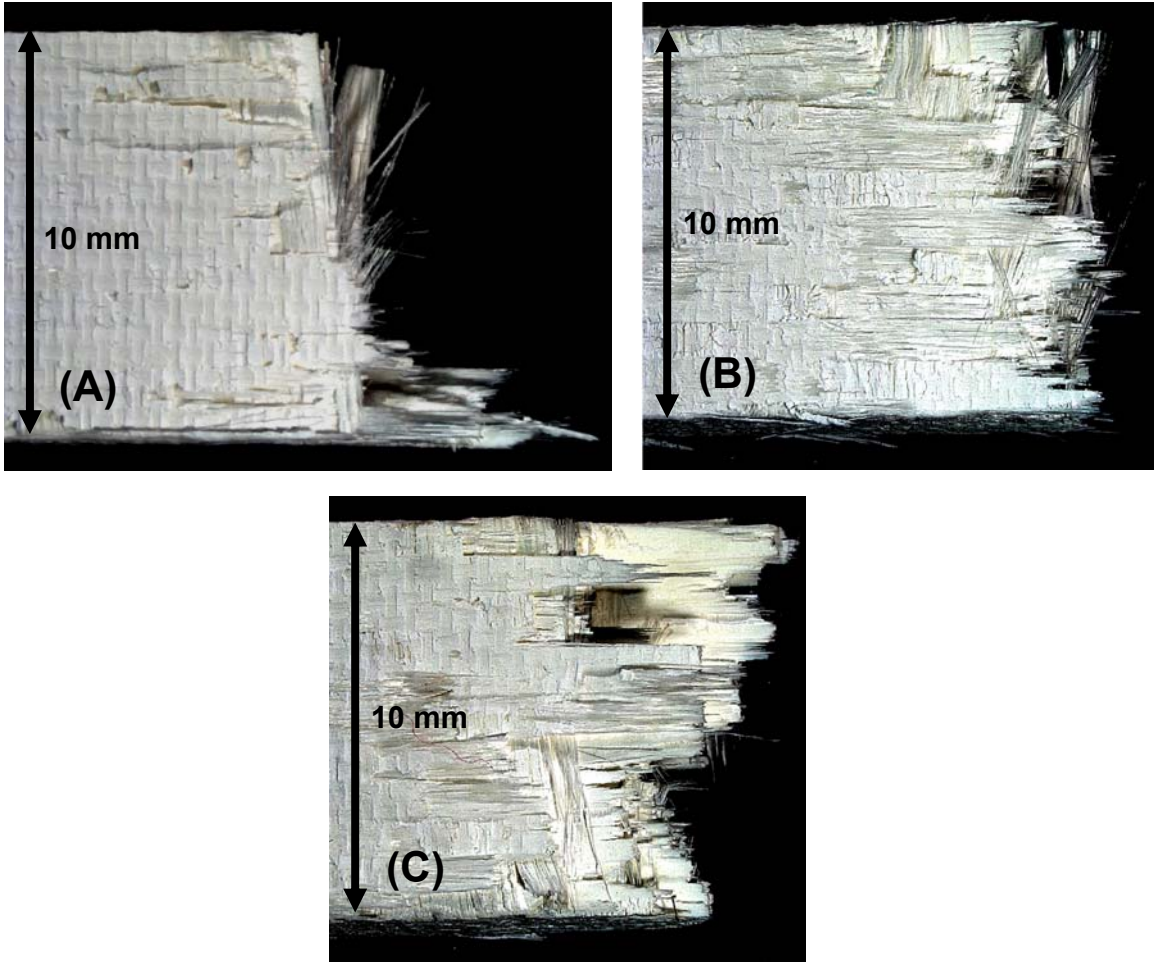
Figure 34. Fracture surfaces of the N720/AM specimens obtained in creep tests conducted at 73 MPa (equivalent to 80 MPa for $V_f = 0.44$) at 1200°C in: (a) air, $t_f > 100$ h, (b) argon, $t_f = 92.8$ h. (c) steam, $t_f = 37$ h.

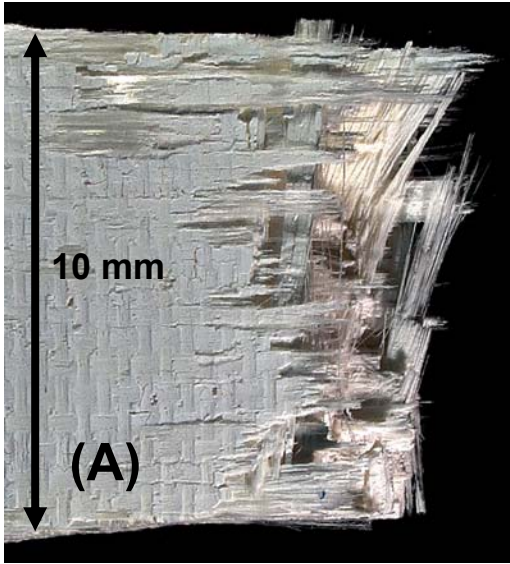
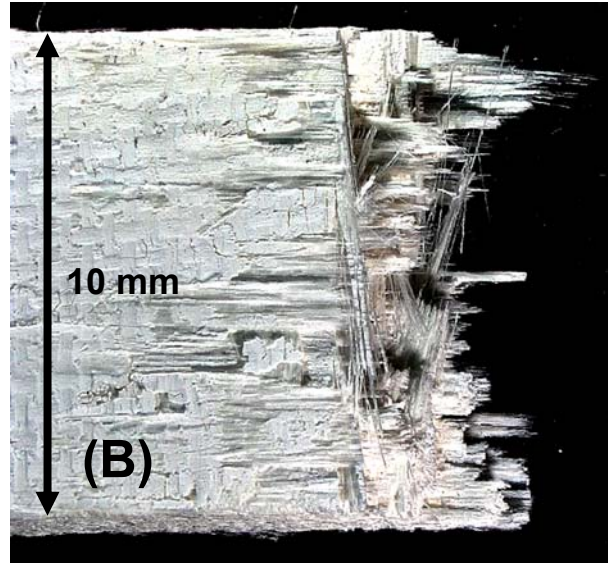
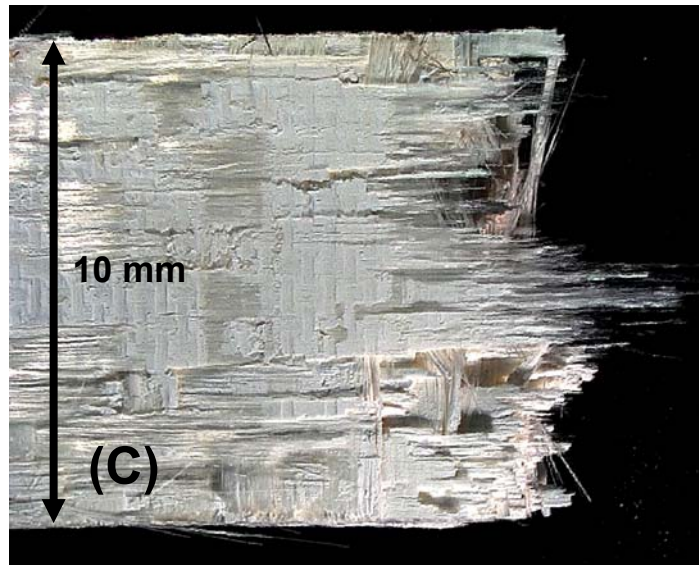
Figure 35. Fracture surfaces of the N720/AM specimens obtained in creep tests conducted at 91 MPa (equivalent to 100 MPa for $V_f = 0.44$) at 1200°C in: (a) air, $t_f = > 100$ h, (b) argon, $t_f = 18.8$ h; (c) steam, $t_f = 4.17$ h.

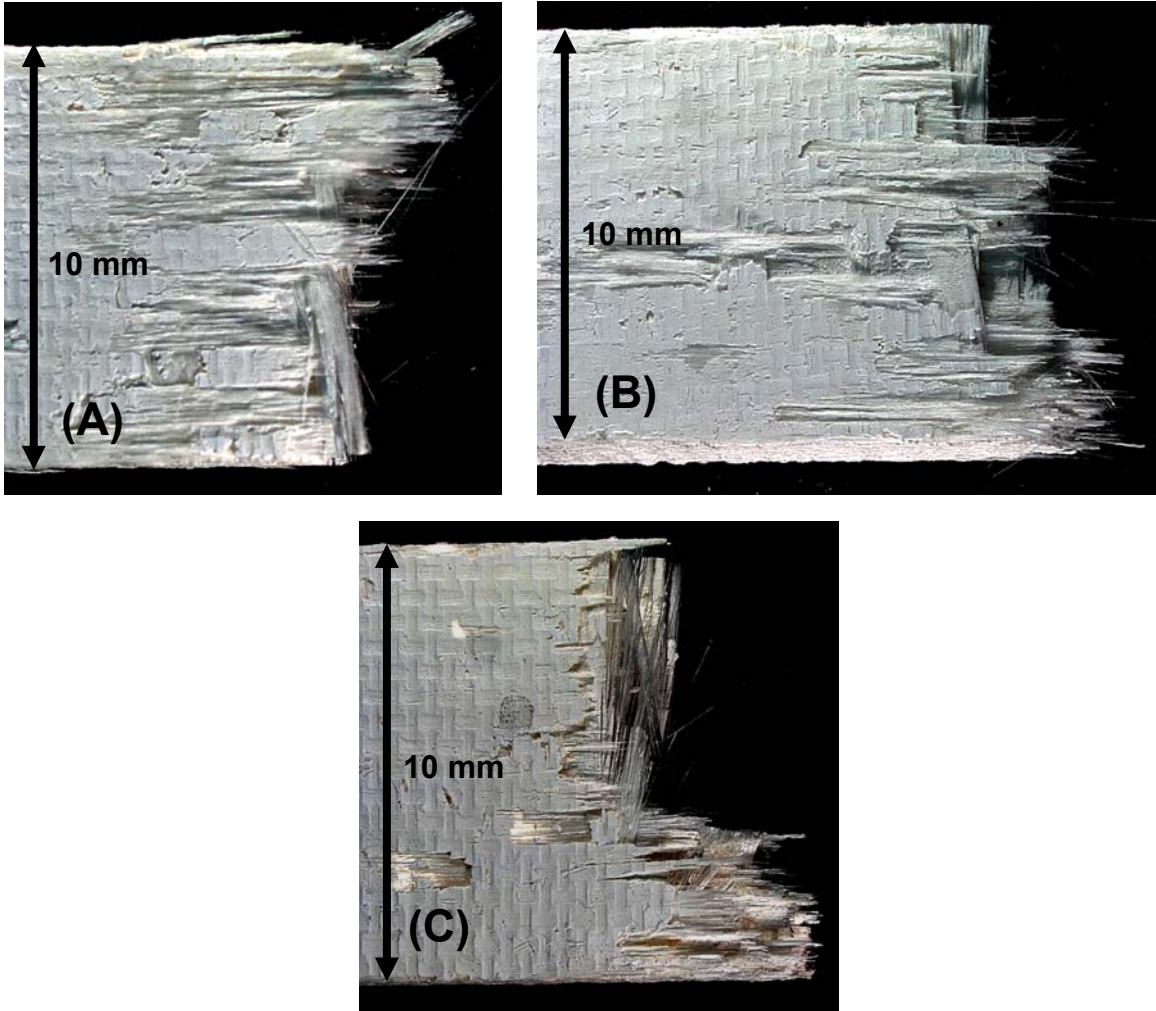
Figure 36. Fracture surfaces of the N720/AM specimens obtained in creep tests conducted at 114 MPa (equivalent to 125 MPa for $V_f = 0.44$) at 1200°C in: (a) air, $t_f = 22.3$, (b) argon, $t_f = .45$ h; (c) steam, $t_f = .38$ h.

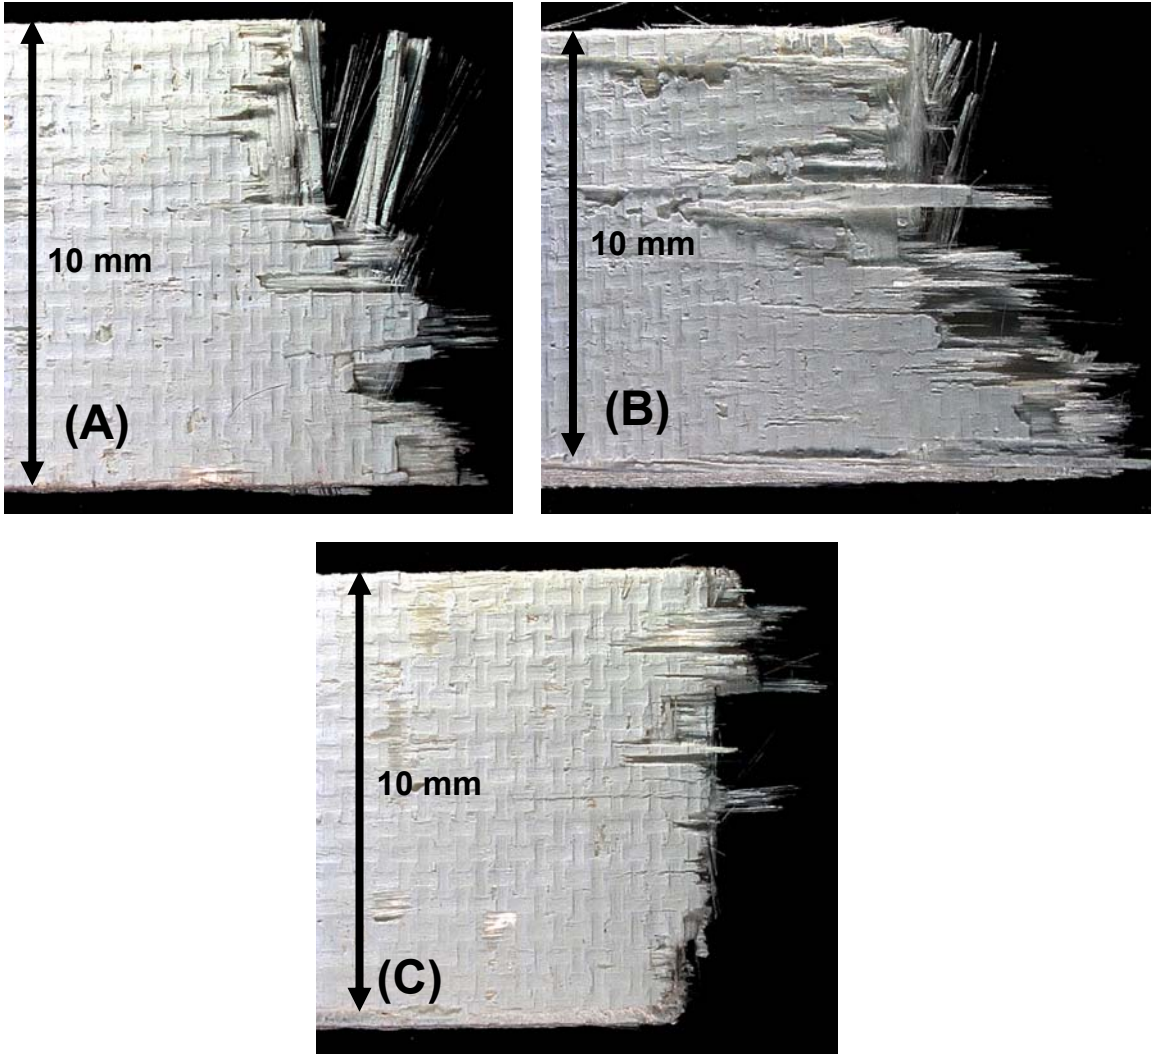
Figure 37. Fracture surfaces of the N720/AM specimens obtained in creep tests conducted at 136 MPa (equivalent to 150 MPa for $V_f = 0.44$) at 1200°C in: (a) air, $t_f = 0.59$, (b) argon, $t_f = 0.07$ h; (c) steam, $t_f = 0.01$ h.

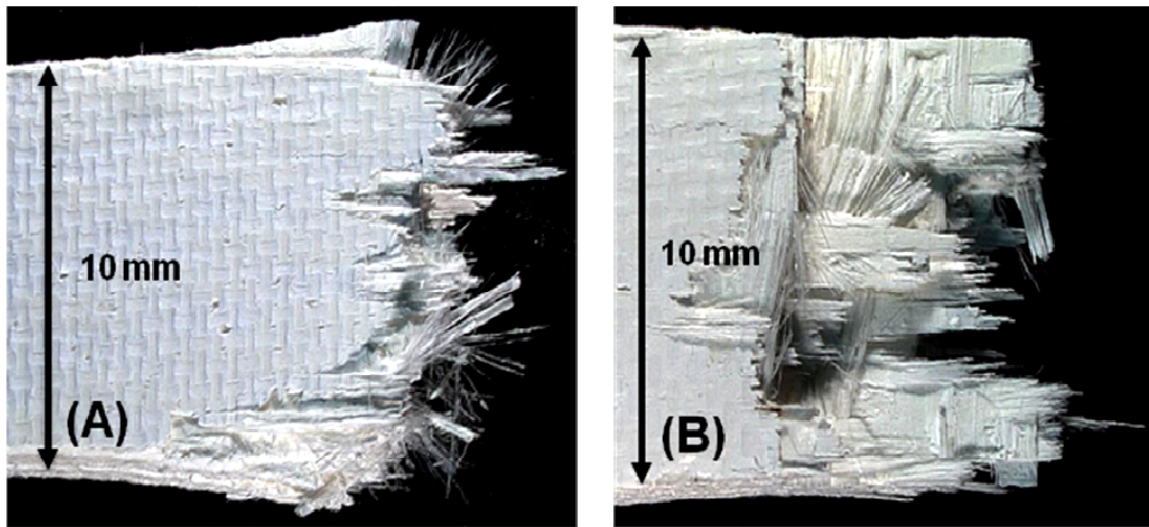
Figure 38. Fracture surfaces of the N720/AM specimens obtained from load controlled tensile tests at 1200°C at: (a) 25 MPa/s, $t_f = 0.0017$ h, (b) .0025 MPa/s, $t_f = 10.4$ h.

to the higher stress rate and shows large sections of fiber pull out. The sample in Figure 38 (b) failed after 10.4 h while the sample in Figure 38 (b) failed after just .0016h or 5.8 seconds.

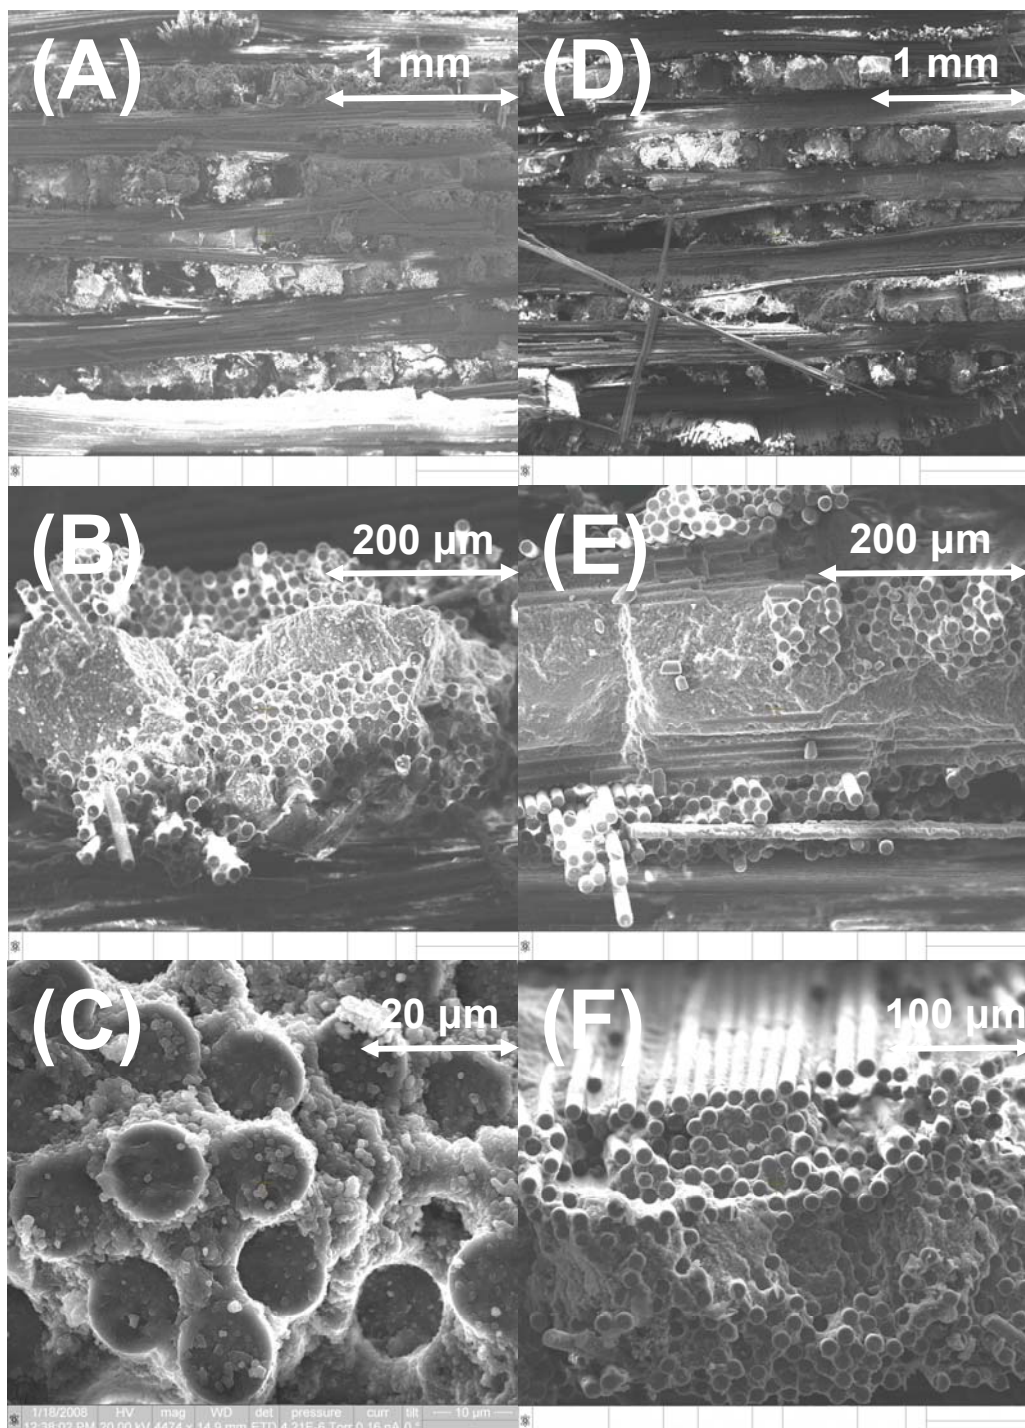
Figure 39. SEM micrographs of N720/AM fracture surfaces produced in creep tests conducted in air at 1200°C at stress levels of: (a)-(c) 73 MPa, (d)-(f) 136 MPa.

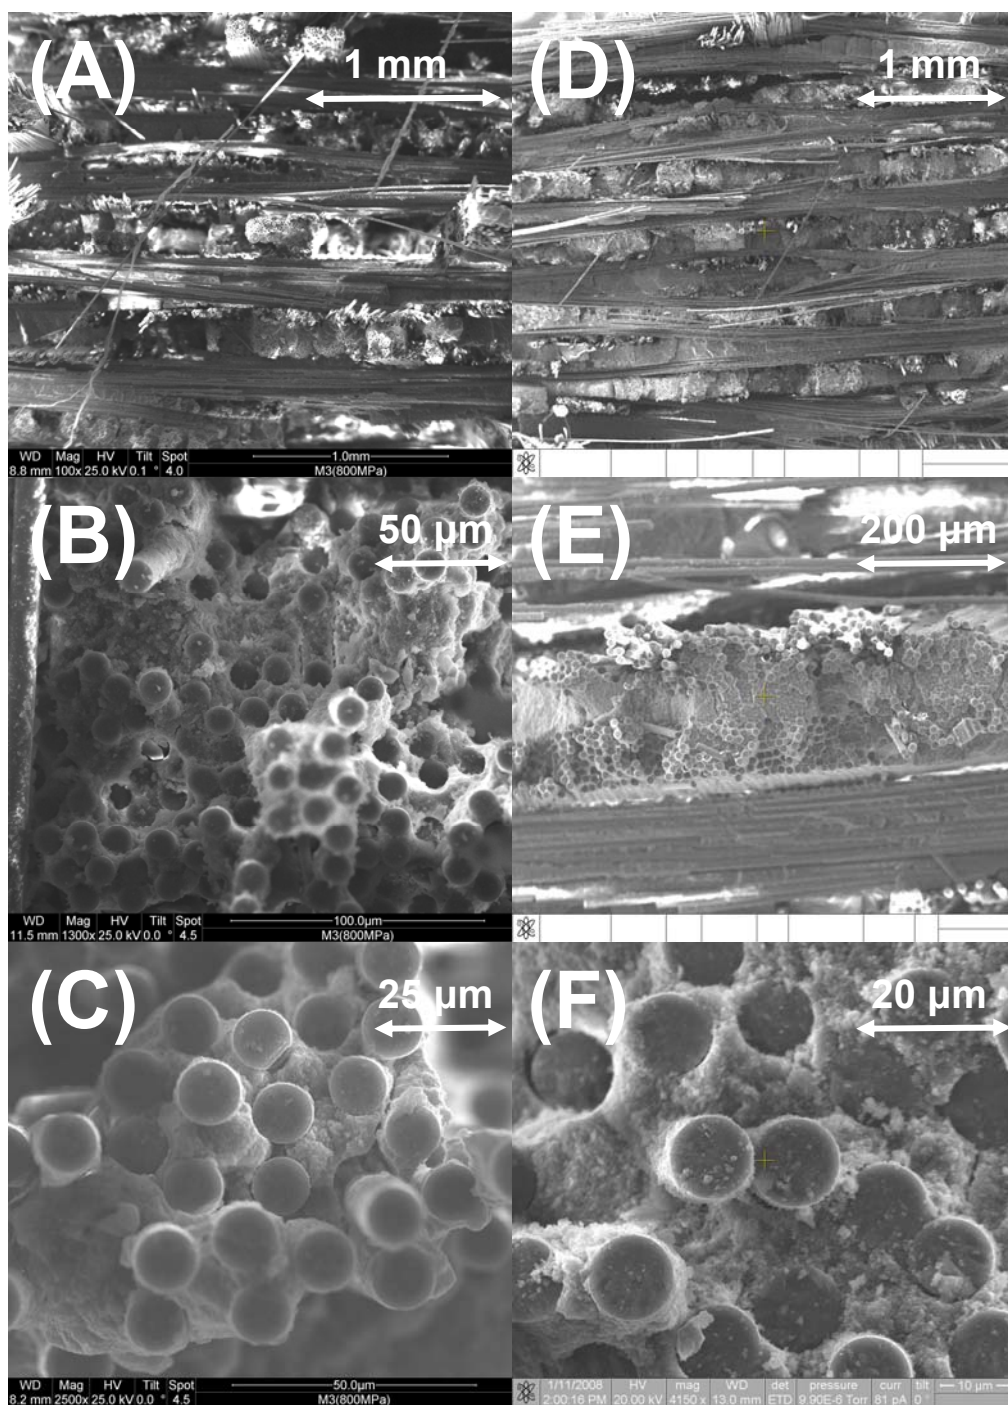
Figure 40. SEM micrographs of N720/AM fracture surfaces produced in creep tests conducted in argon at 1200°C at stress levels of: (a)-(c) 73 MPa, (d)-(f) 136 MPa.

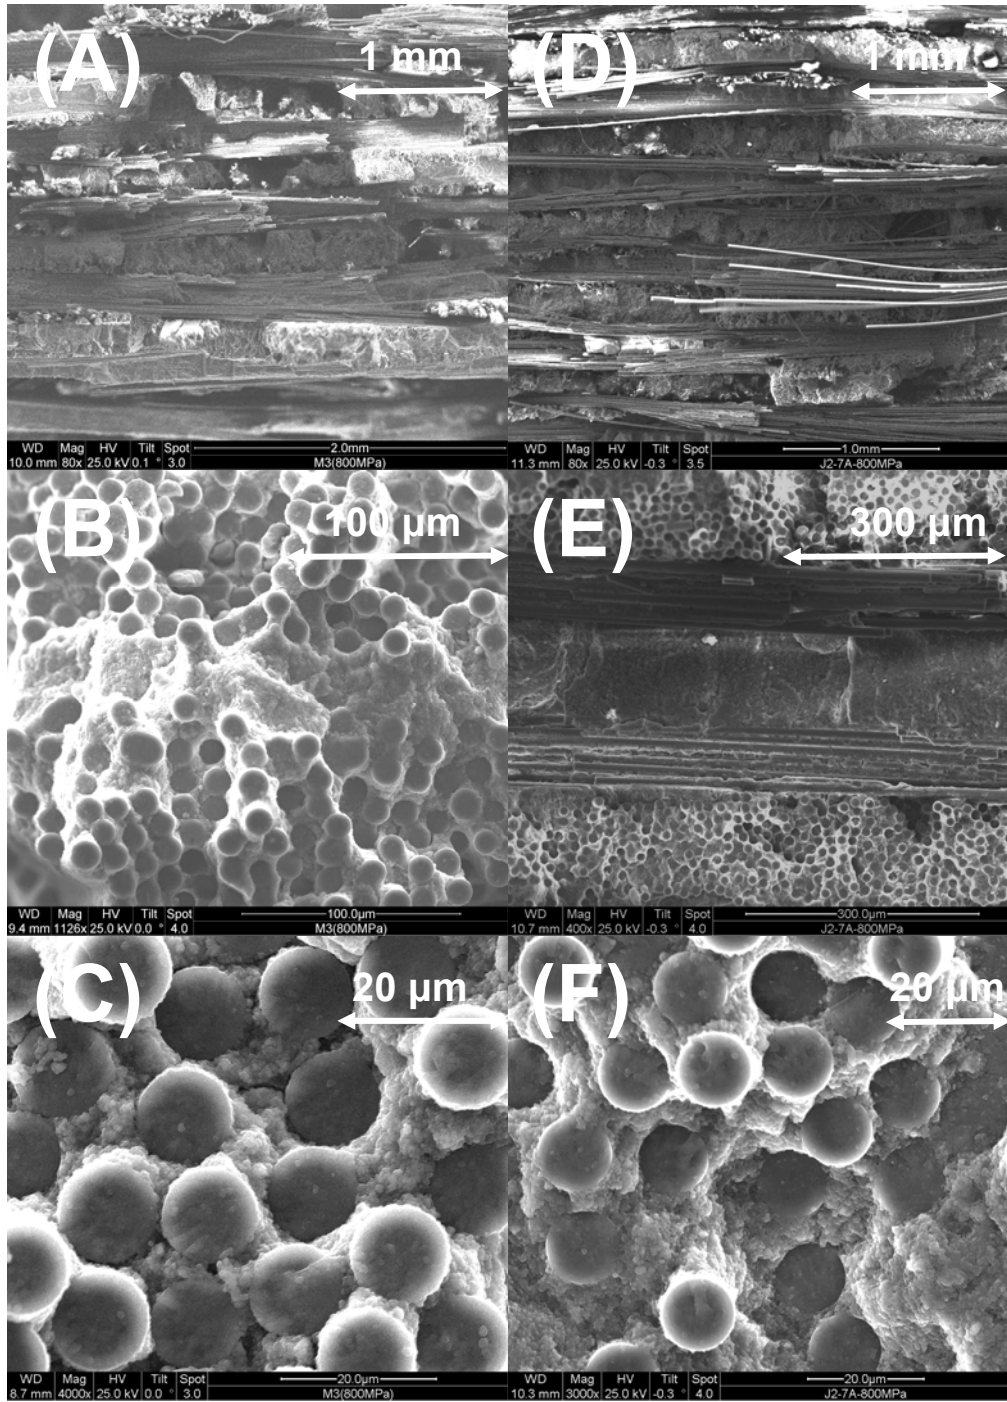
Figure 41. SEM micrographs of N720/AM fracture surfaces produced in creep tests conducted in steam at 1200°C at stress levels of: (a)-(c) 73 MPa, (d)-(f) 136 MPa.

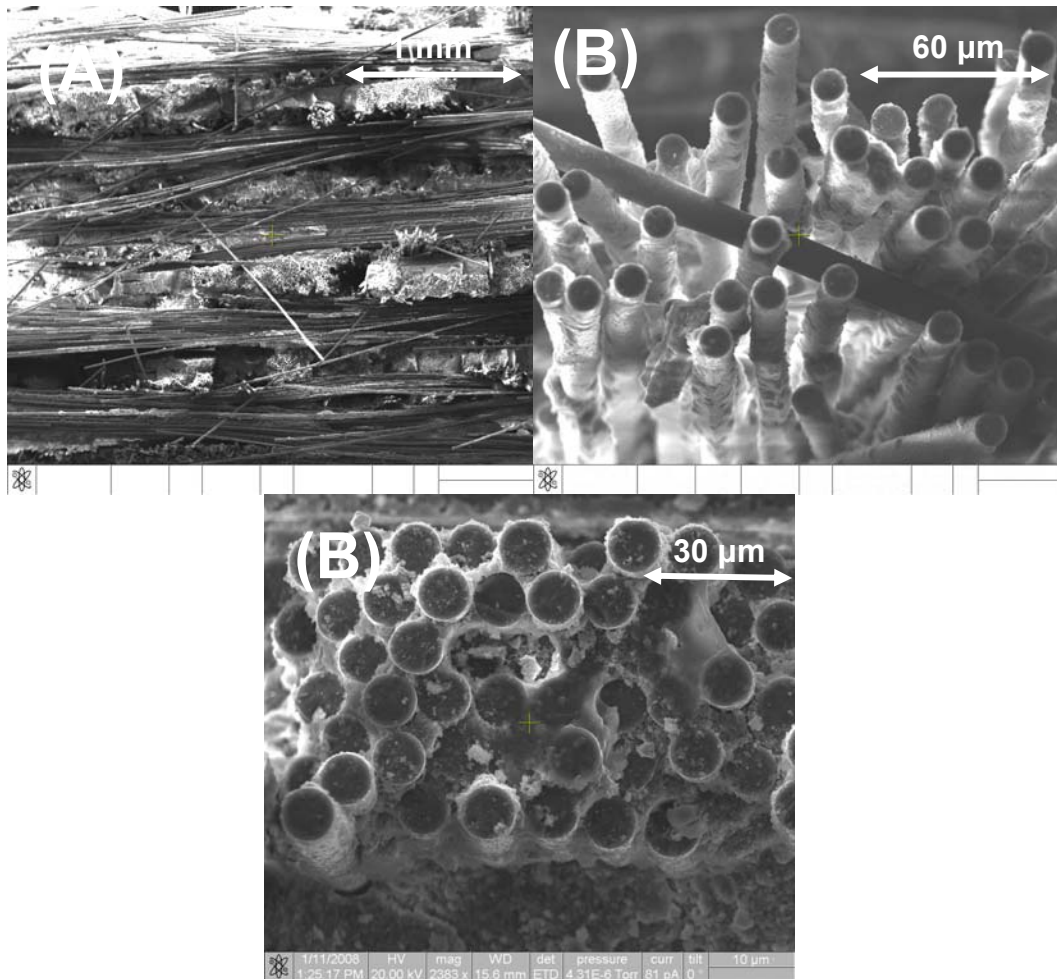
Figure 42. SEM micrographs of N720/AM fracture surfaces obtained in monotonic tensile tests in air at 1200°C, various magnifications.
